FACILITY STATUS CHANGE FORM (for DOE/RL-2010-34 Facilities)

Date Submitted: 12/18/2013 Originator: Clay McCurley Phone: 942-8928	Area: 100-D Facility ID: 183D Water Treatment Plant Action Memorandum: General Hanford Site Decommissioning Activities	Control #: D4-100D-004
--	--	----------------------------------

D4 Project Facility Completion Form

Attachment 4

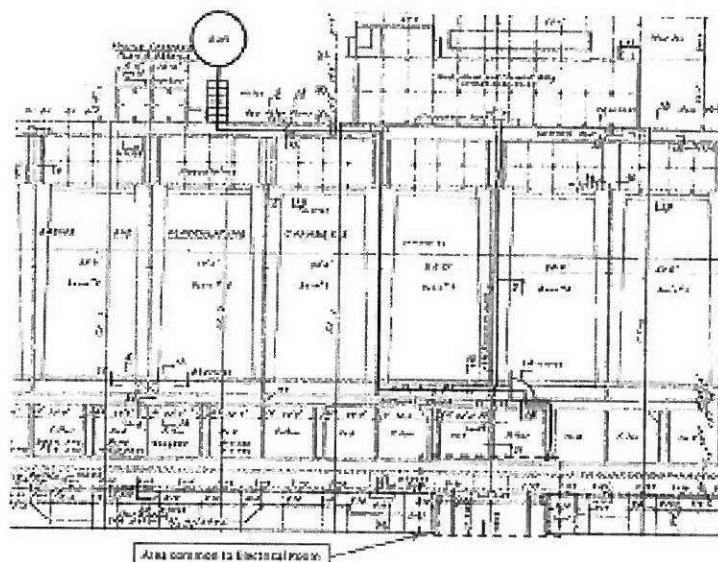
Figure 1 – 183-D Walk Down Path to Filter Building, and Pump Room and Electrical Switchgear

A walk down was performed on May 03, 2012 to determine the structural adequacy of the 183-D Water Filter Plant – Filter Building and Pump Room. The primary purpose for the walk down was to determine worker safety for IH sampling. The area was assessed for the possibility of performing routine work to prepare the building for eventual Decontamination and Demolition. Attachment E details the results of the structural evaluation. Figure 1 shows the path taken to the electrical room during the walk down.

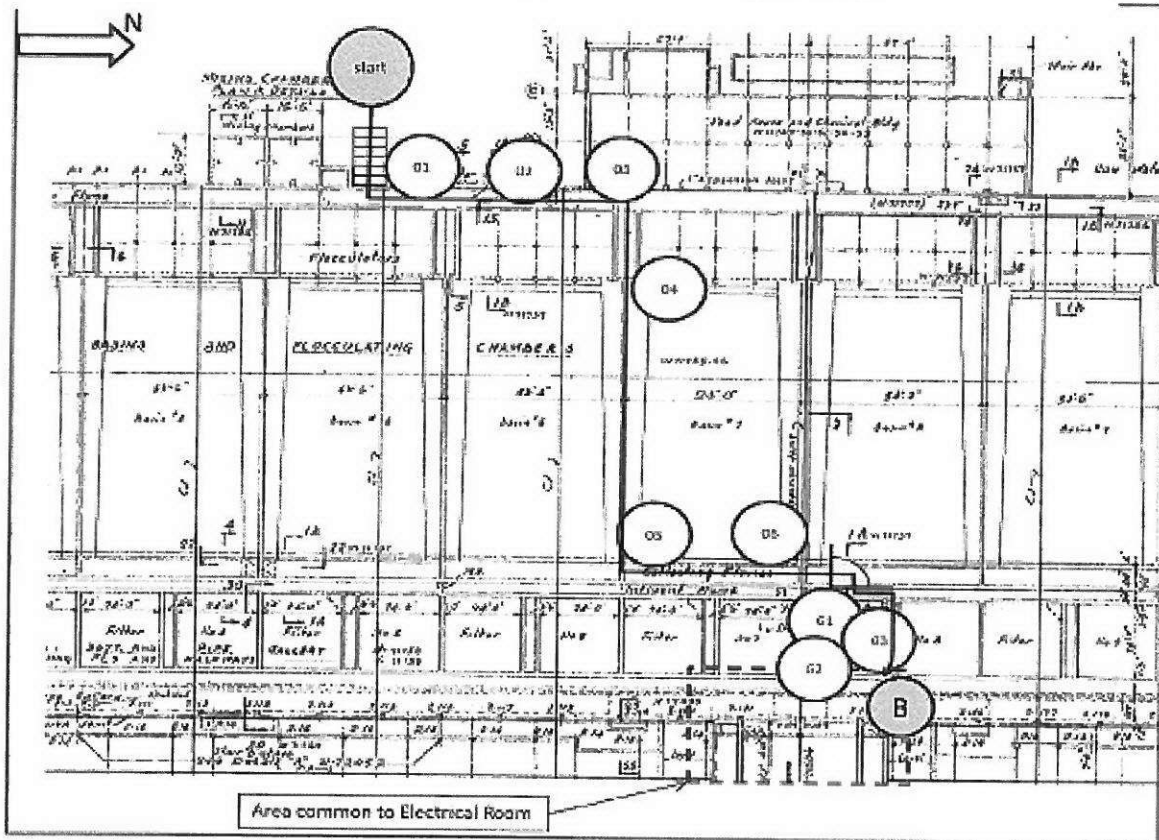
Figure 1 - Exterior Building and Filter Room Inspection Map

- **EXTERIOR STRUCTURE, PATHS AND WALKWAYS** – The walkways exhibit concrete scaling due to the being exposed to a corrosive environment. Some of the walkways exhibit concrete spall with exposed rebar. The rebar common to these areas exhibited moderate corrosion. There are some wooden stairs that were NOT secured properly that are tripping hazards.

The pre-cast concrete roof panels exhibit severe degradation indicative of a structure that has been exposed to a corrosive environment. There is exposed rebar and significant deflections of the panels. In some cases, large pieces of the concrete panels have become detached and have fallen to the Filter Building floor. The panels also exhibited discoloration that is indicative of a potential chemical attack. These areas had "white stains" on their surfaces.

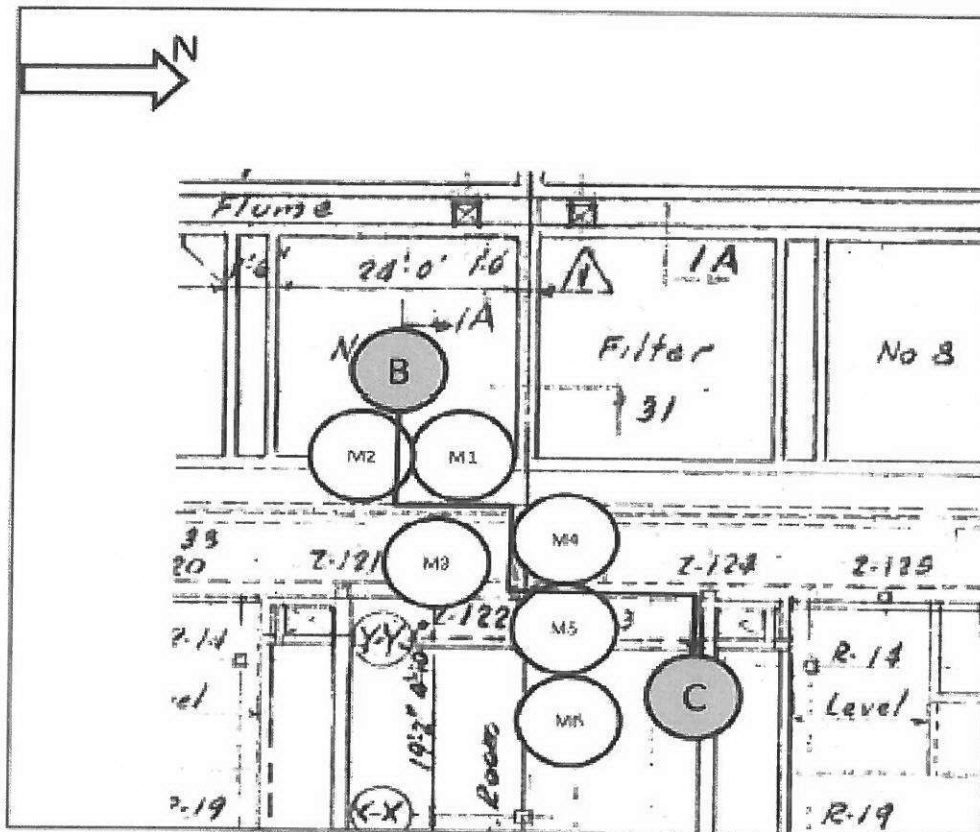
Figure 2 - Pump Room Inspection Map

- **PUMP ROOM** – The masonry walls appear NOT to have structurally detrimental issues. These walls did NOT exhibit cracking in the grout nor did they exhibit excessive deflection.

The pre-cast concrete roof panels exhibit severe degradation. The rebar of these panels were exposed to the environment. There were also panels which exhibited discoloration. These areas had "white stains" on its surface.
